Modifications to MTH PS3 Tender Red/Black power wire Positioning
Mark DiVecchio (SanDiegoMark)
17 September 2017

I have a 30-1660-1 P&LE (NYC) 0-6-0 USRA Steam Switcher #9060 with PS3.

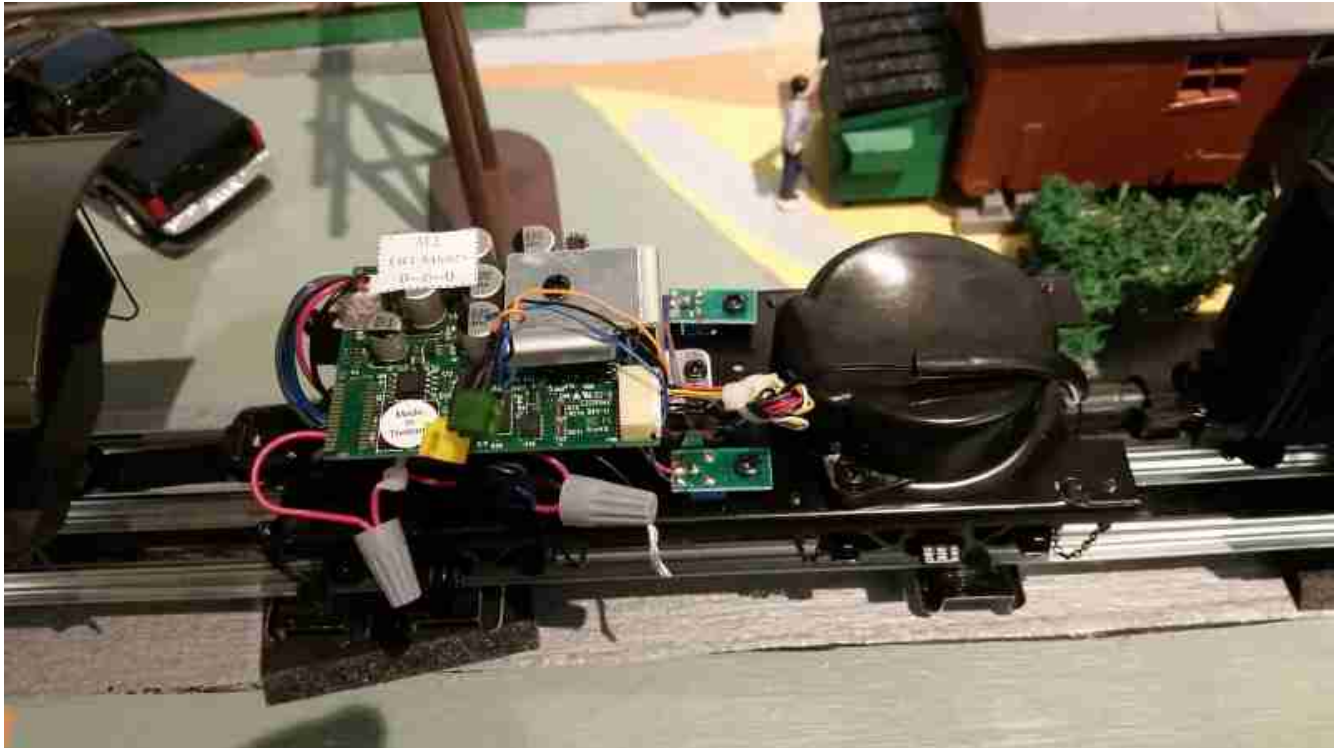
I know the DCS signal comes in on the power wires. I could see the red and black power wires stuffed underneath the circuit board. So I wanted to check them. I wiggled the wire bundle from the tether connector out from under the circuit board. I noticed there were two black wires supplying power. Sometimes DCS signals get confused if the signal can travel two paths from the TIU to the engine.

So I disconnected one of the black wires and put the tender back on the track.

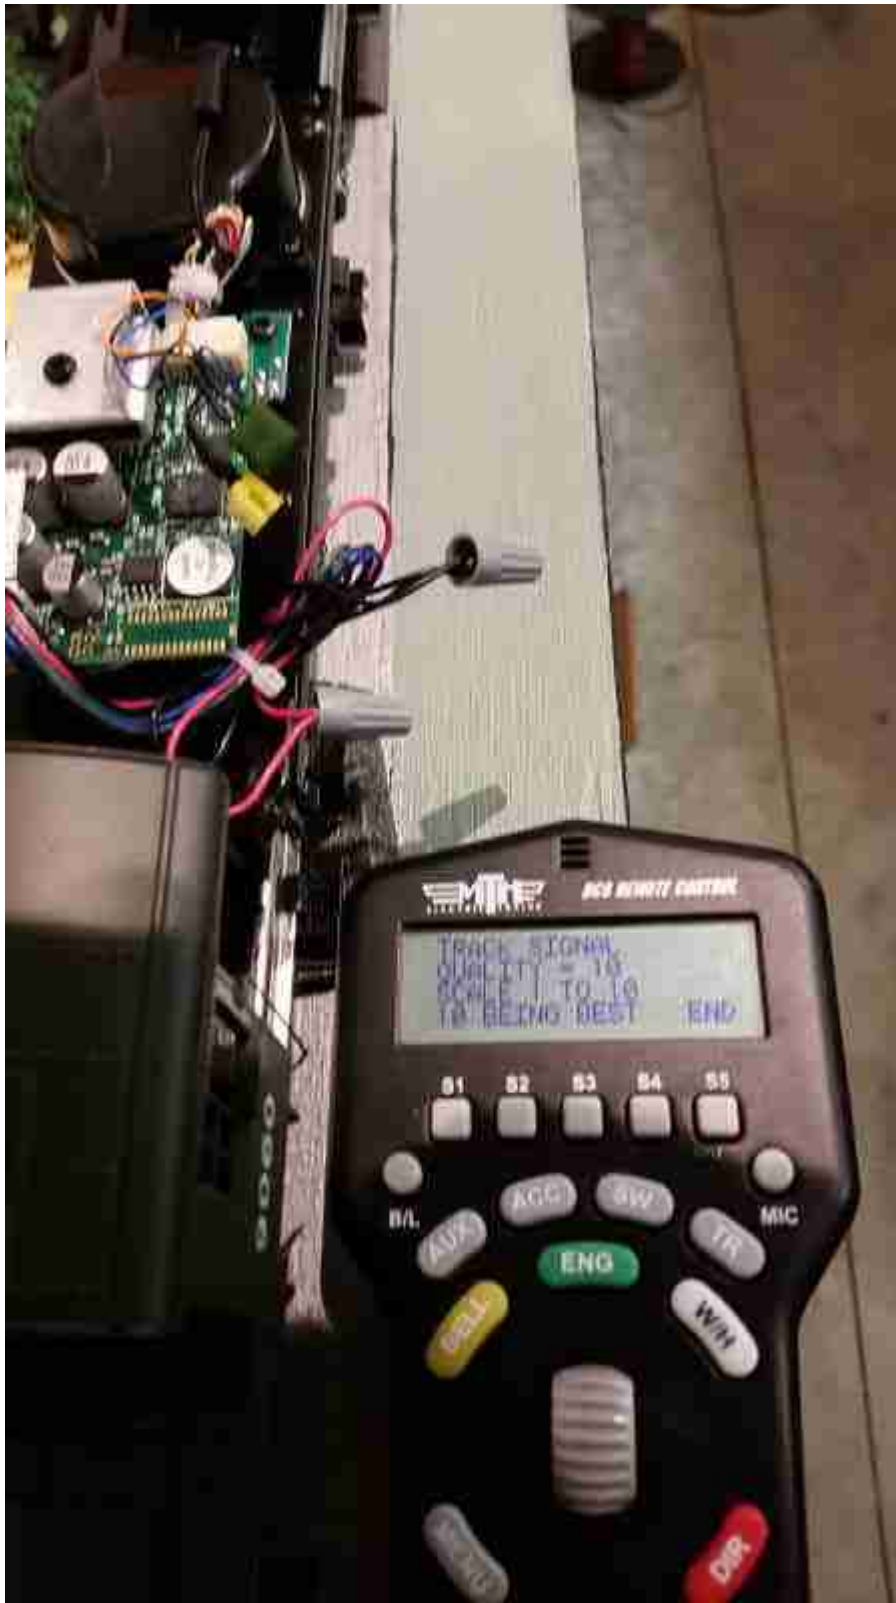
Whoa! The track signal jumped to 10. I reconnected the black wire and it stayed at 10.

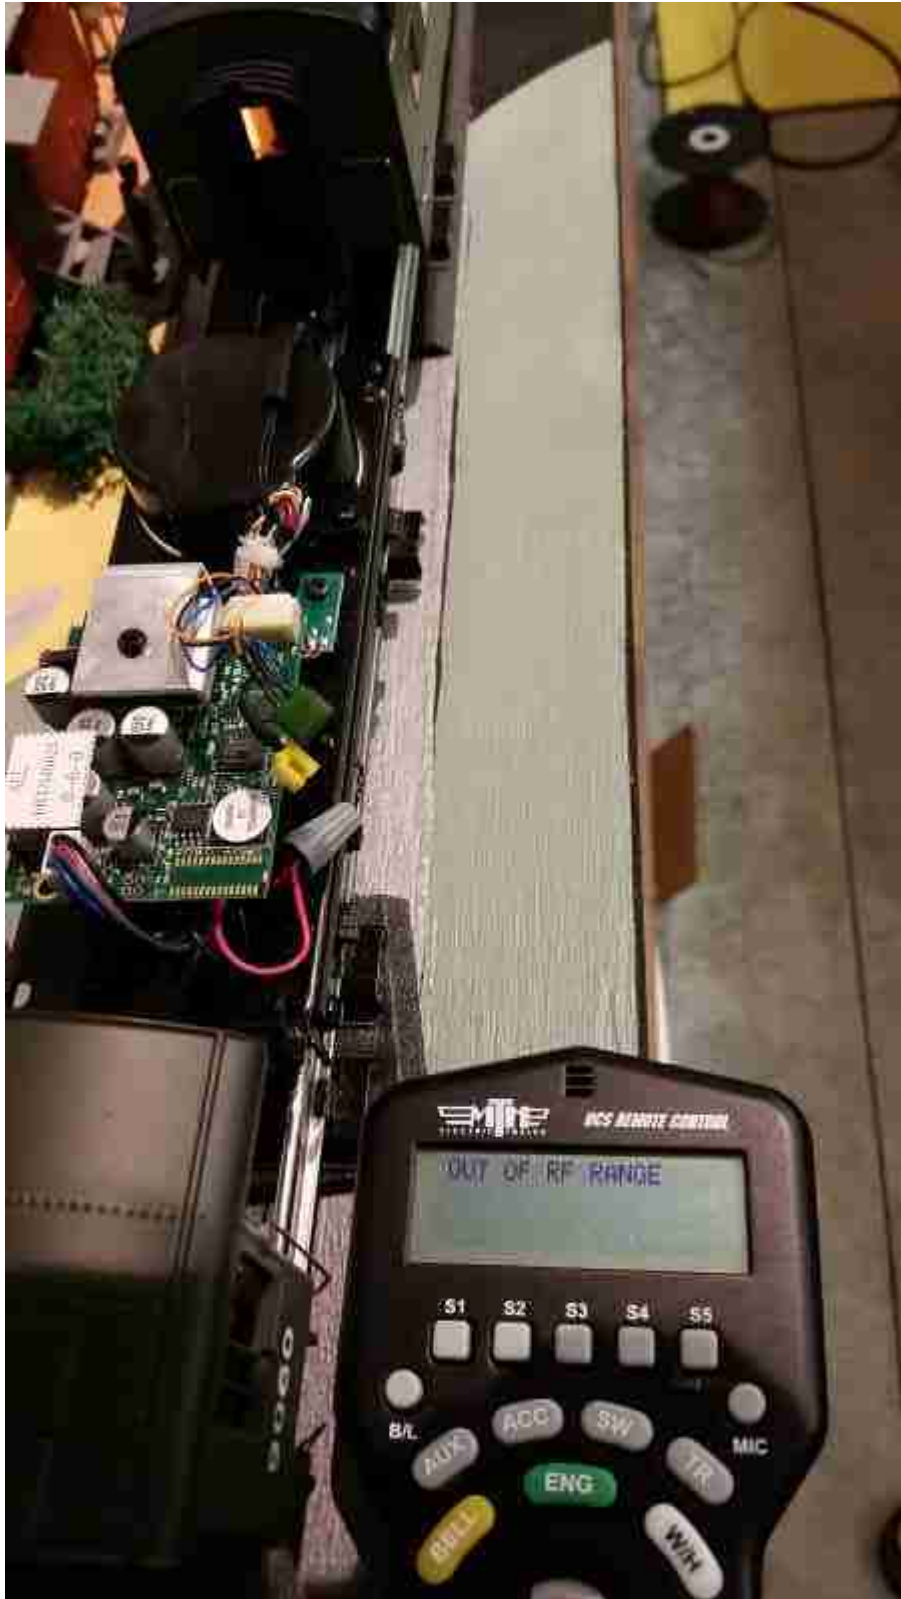
So I stuffed the wire bundle back under the circuit board and the track signal dropped down to OUT-OF-RANGE-1-2-3

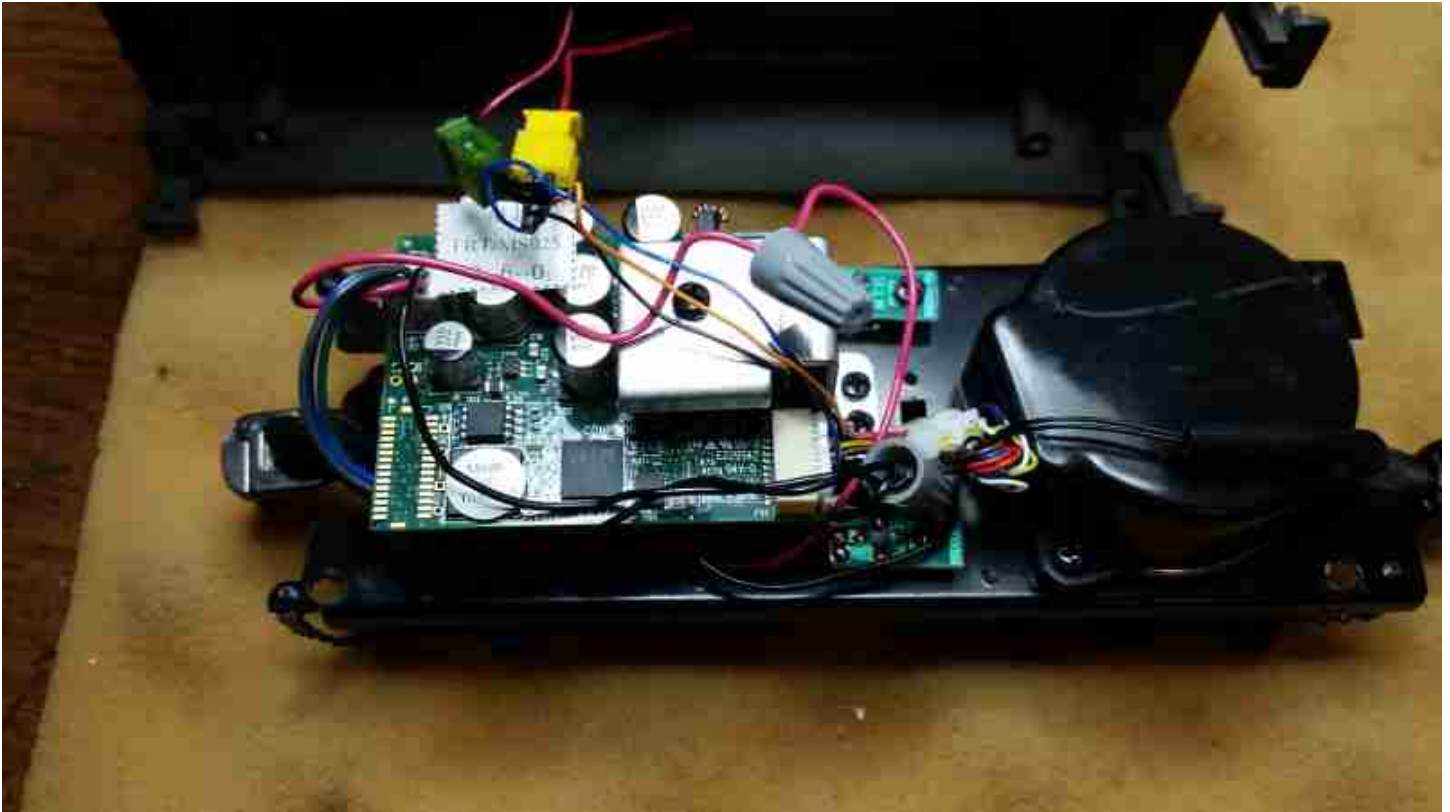
So I don't know why this worked. Some kind of the interaction between the power wires (carrying the DCS signal) and the circuitry on the PCB.

So did just pulling the bundle out from underneath the circuit board cause this effect? After more testing, moving the bundle underneath then outside a few times confirmed that this was the problem. I unbundled the red and black power wires and routed them over top of the circuit board. I stuffed the remaining wires in the bundle back underneath the circuit board. Track Signals back at 10.
