Modifications to MTH PS3 Tender Red/Black power wire Positioning
Mark DiVecchio (SanDiegoMark)
17 September 2017

I have a 30-1660-1 P&LE (NYC) 0-6-0 USRA Steam Switcher #9060 with PS3.

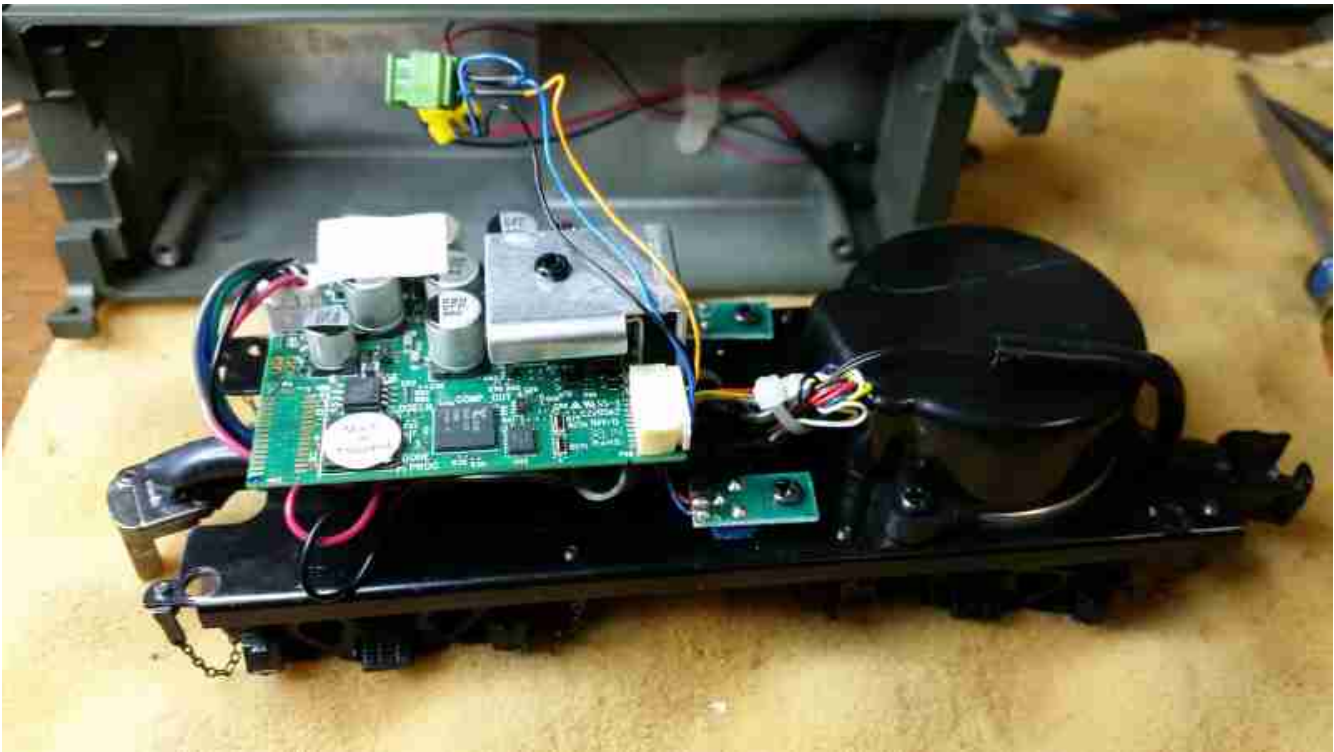
In the PS3 steam engines, the PS3 circuit board is in the tender so I removed the tender shell.

I know the DCS signal comes in on the power wires. I could see the red and black power wires stuffed underneath the circuit board. So I wanted to check them. I wiggled the wire bundle from the tether connector out from under the circuit board. I noticed there were two black wires supplying power. Sometimes DCS signals get confused if the signal can travel two paths from the TIU to the engine.
